Bridge Inspection Report

026-38-03430 A
SR 26
over
SALAMONIE RIVER

FRACTURE CRITICAL INSPECTION REPORT

Bridge No. 026-38-03430 A, a seven (7) panel Pratt through truss, carries SR 26 over the Salamonie River in Jay County, Indiana at RP 141+23. The bridge was built in 1941 and is identified as a Historic Non-Select bridge. The bridge was repaired in 1979 with a new deck and some structural repairs. The structure length is 154.7 feet long with a maximum span of 150 feet. The bridge has a clear roadway width of 28 feet accommodating two lanes of traffic and an out to out width of 29 feet. The bridge is currently load rated for 20 tons. The average daily traffic (ADT) in 2014 was estimated at 2541 vehicles per day.

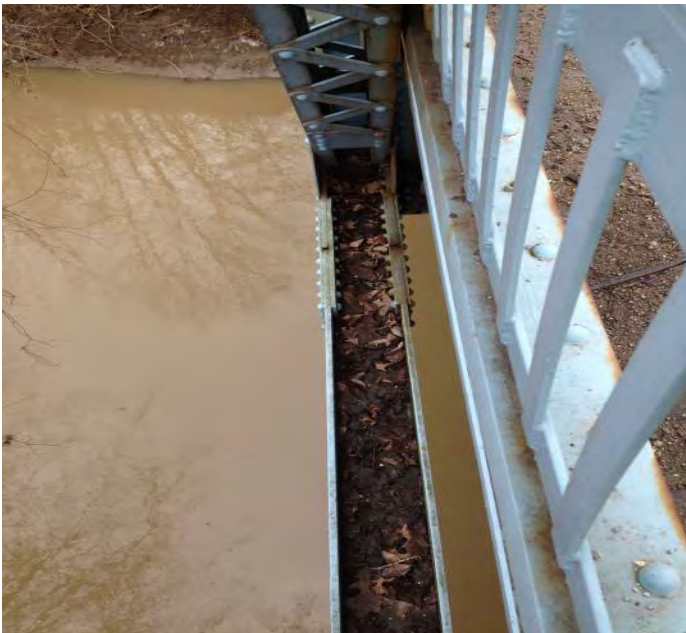
Tree leaves and other debris has filled up many areas of the lower truss chords and lower truss connections. This debris is allowing moisture and chlorides to stay in contact with the steel which results in continued corrosion.

PHOTO 1 Description 007 - Looking E at typical debris in lower truss chords - 26-38-03430A Salamonie River NBI 007040 01-21-2015.JPG

The lower truss chords and connection areas should be thoroughly cleaned at least twice a year in order to keep corrosion to a minimum on this historic bridge. They should be cleaned in late November after all leaves have fallen, and again in late April after all salting activities are complete.

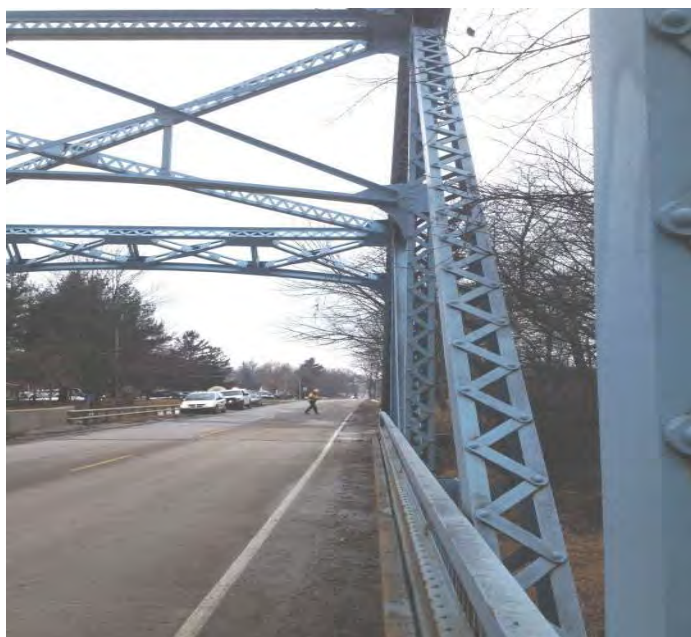
There are trees that protrude through the North Truss and over the north shoulder area, over the bridge deck. The leaves from these trees fall off and fill the lower truss chords all winter long. These trees should be cut way back from the truss. The truss needs to be cleaned out at least twice a year in order to prevent corrosion, so as to keep this bridge in service for many more years.

PHOTO 1 Description 009 - Looking W at typical tree branches extending through truss members - 26-38-03430A Salamonie River NBI 007040 01-21-2015.JPG

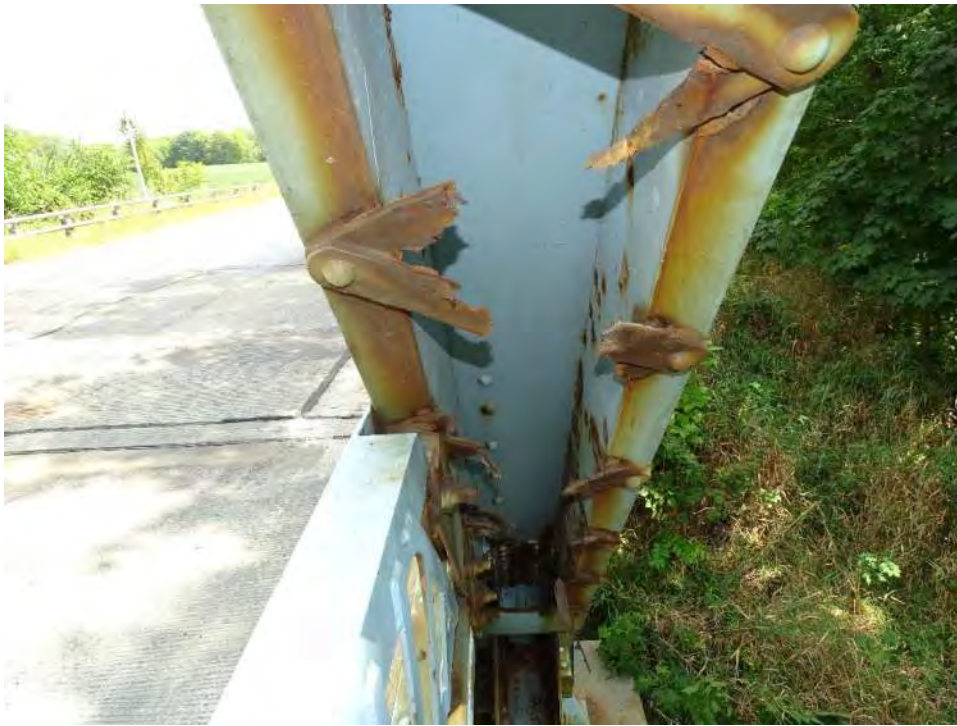
Steel Lacings have corrosion & major section loss or are missing @ NW & SE end posts, (both L0-U1's), over the lower +- 8-feet.

Photo 9: Southeast End Post - Damaged Lacing Bars

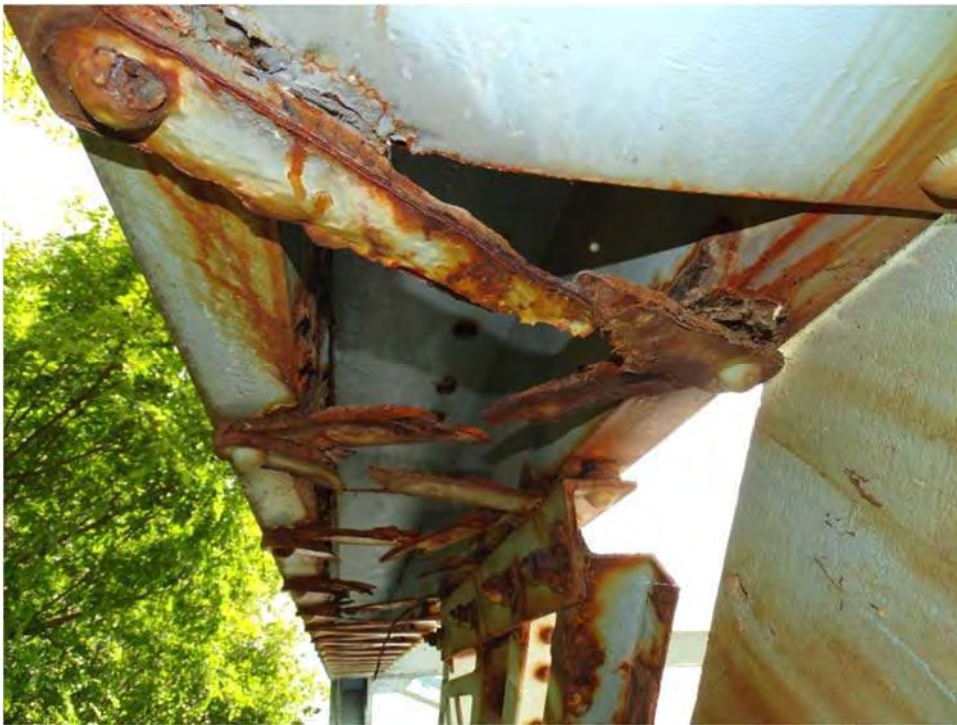
Photo 10: Northwest End Post - Damaged Lacing Bars

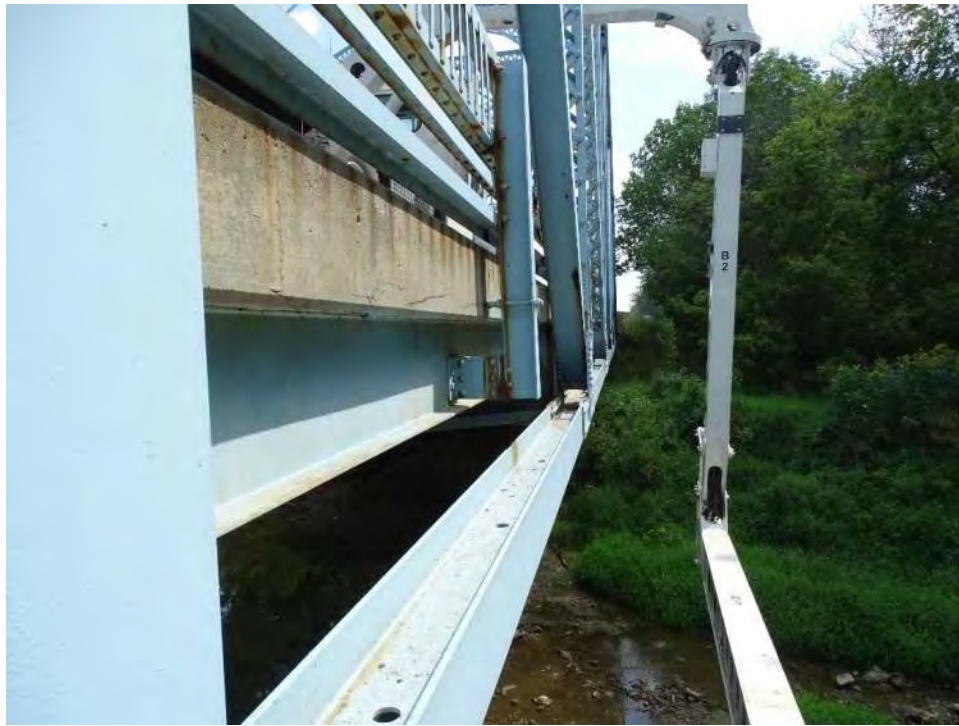
Photo 11: Looking W along S Truss at Typical Guardrail Connection

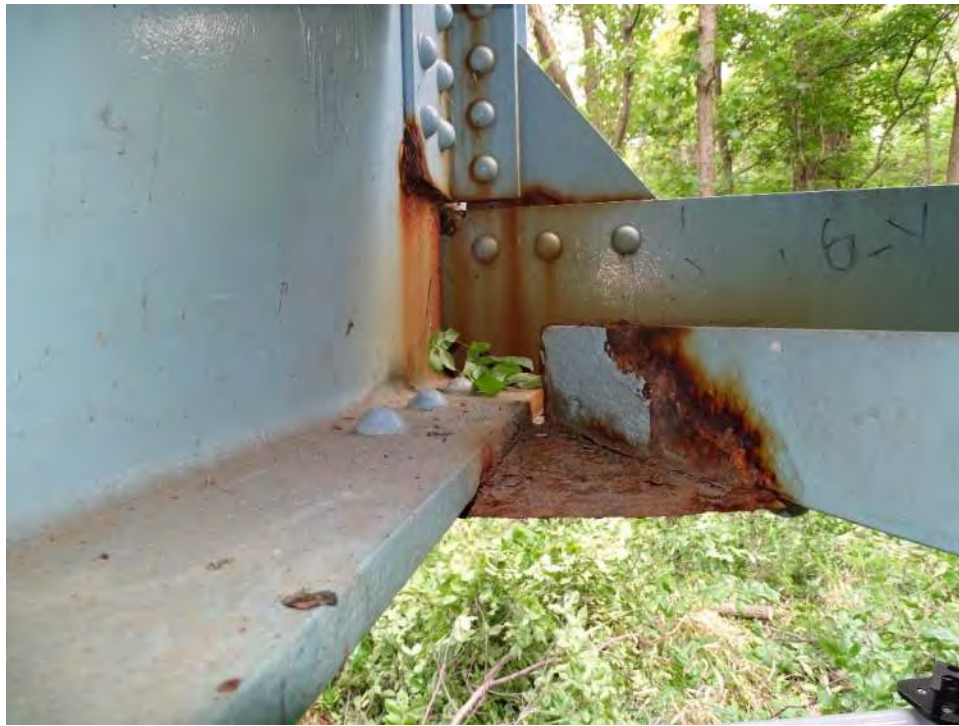
Photo 13: L1-Y- Floor Beam 7 (from West End) Typical Condition at Bracing and Gusset Plate

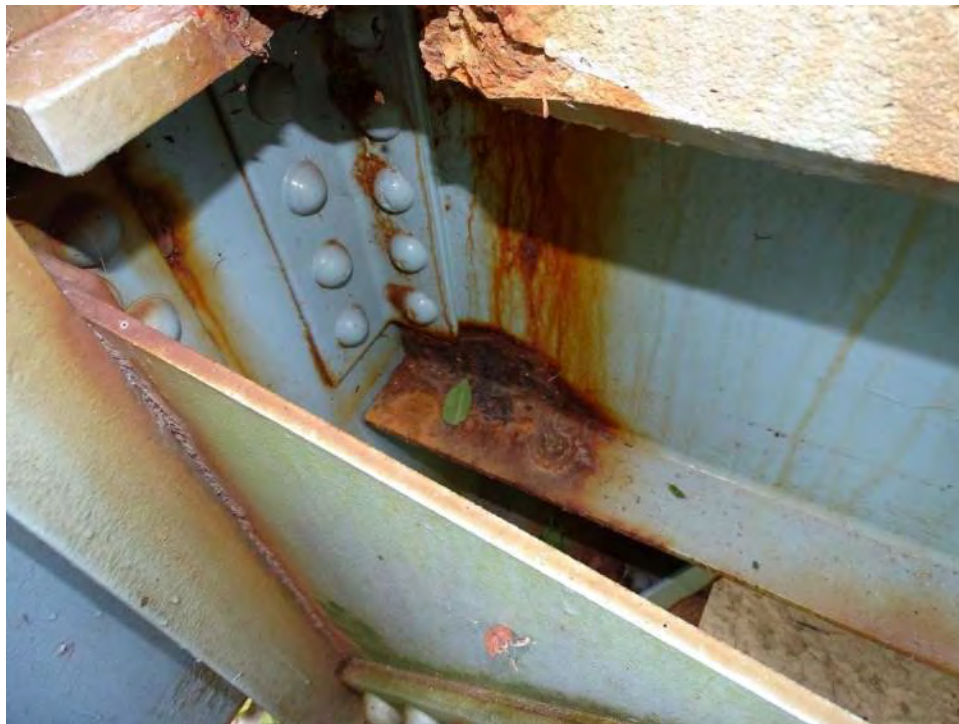
Photo 14: L2-Y North Stringer Section Loss 4" x 8" x 1/8" in Web and 4" x 6" x 1/8" in Bottom Flange

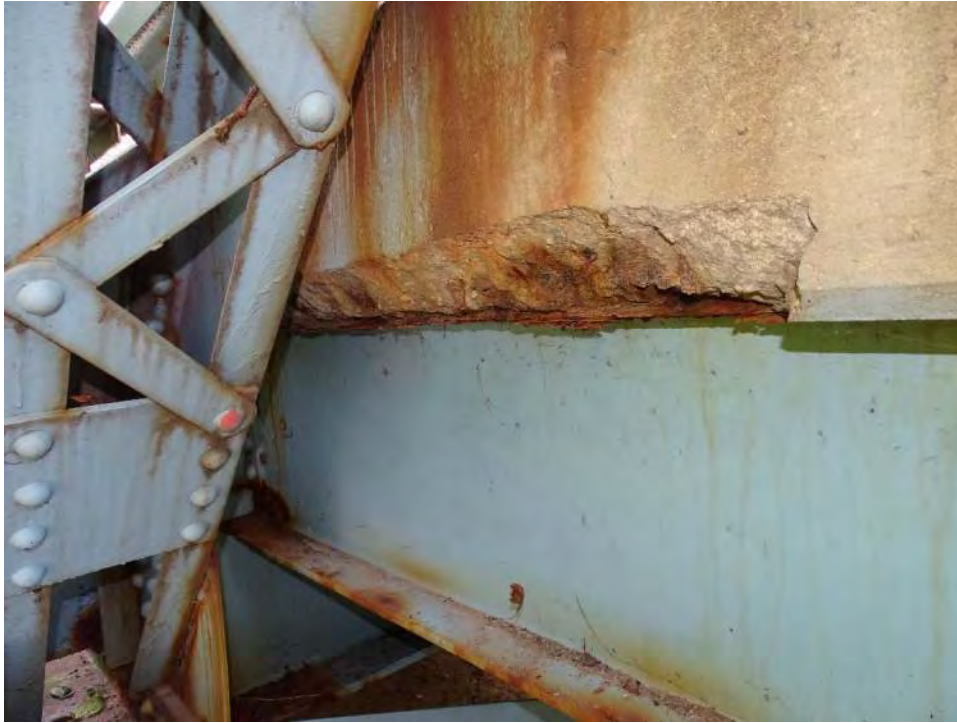
Photo 15: Concrete Coping Spall 6"x3"x4' Between L2-L3 Y – Note Delamination of Stringer Top Flange

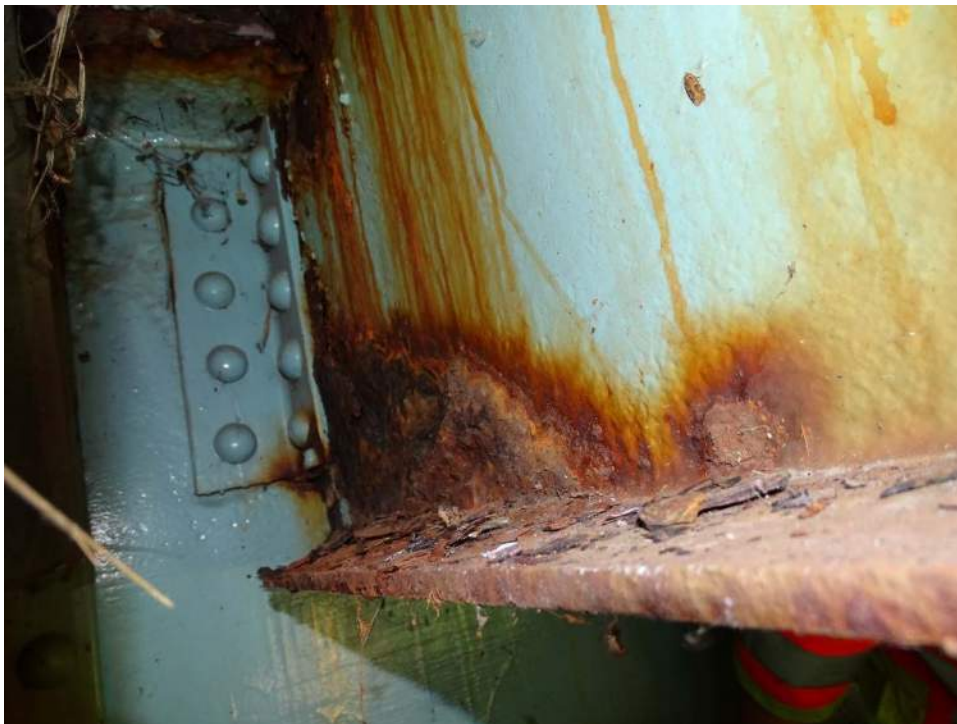
Photo 16: Stringer 1 at Northeast Corner - Note Heavy Rust, Section Loss (1/4" x 3" x 8" in Flange; 1/8" x 6" x 8" in Web), and Debris

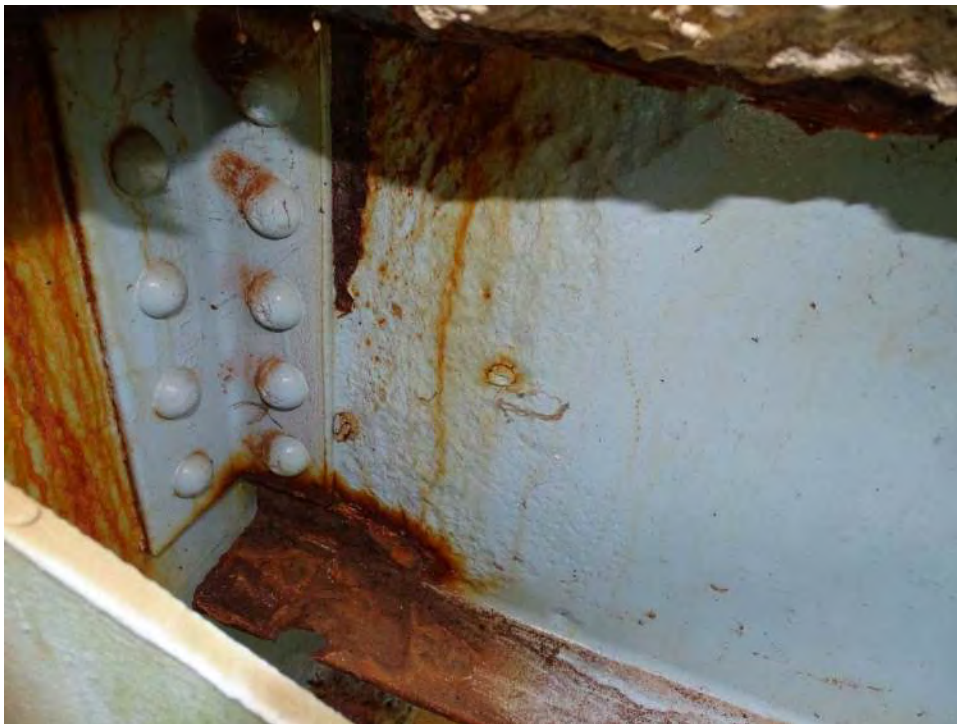
- Fascia stringer, L3-L2 at L3-Y – 1" diameter hole in bottom flange; remaining steel tapers down to paper thin at edges (See Photo 18);
- Stringer 1 at Northeast corner (L0-Y) – section loss (1/4" x 3" x 8" in Flange; 1/8" x 6" x 8" in Web), debris collecting on bottom flange, etc. (See Photo 16)
- Section loss to Stringer 1 (L1-L2 Y) approximately 1/8" x 4" x 8" in Web and 1/8" x 4" x 6" in Bottom Flange (See Photo 14)
- Stringer #2 from the north on E. side of floor beam #4 - top flange damaged with a 2" tear in the coped area.

Photo 18: L3-Y North Stringer (L3-L2) Heavy Pitting and Section Loss – $\sim \frac{1}{4}$ " x 6" x 8" in Bottom Flange with a 1 $\frac{1}{2}$ " Diameter Hole

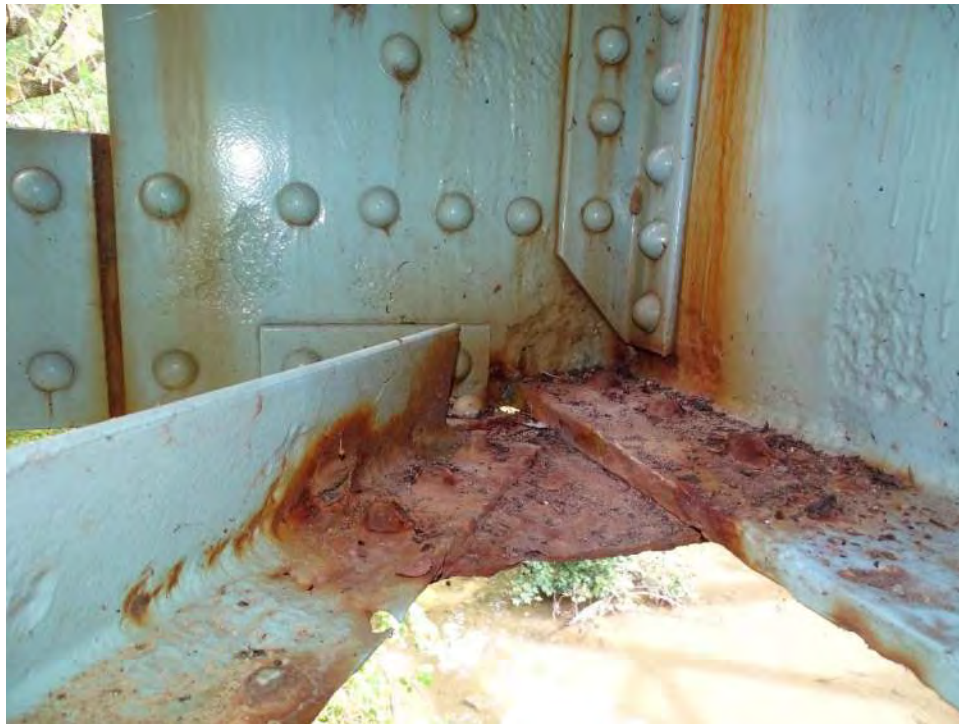
Photo 19: Heavy Rust, Pitting and Section Loss on North End of FB 5, Gusset Plate and Lateral Bracing. Bracing reduced by 50% along end 24" and Gusset Plate Reduced by 50%-75%.

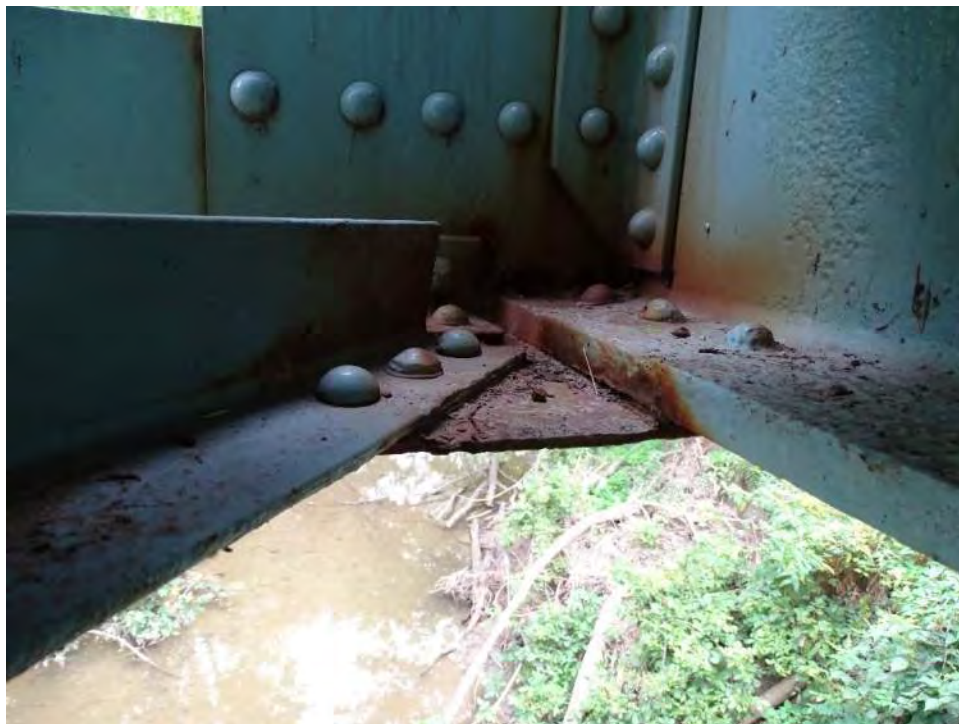
Photo 20: Northwest end of Floor Beam 5 - Note Gusset Plate Connections Pack Rust up to 1/2"

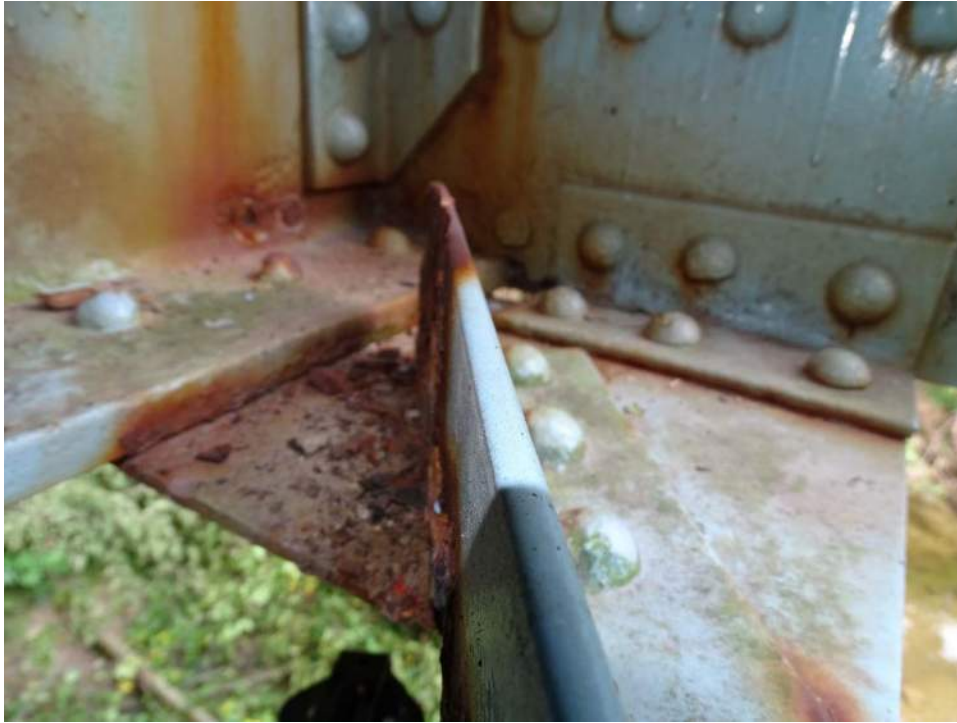
Photo 21: Northeast end of Floor beam 5 - Note Gusset Plate and Bracing Section Loss ~ 50% of end 12"

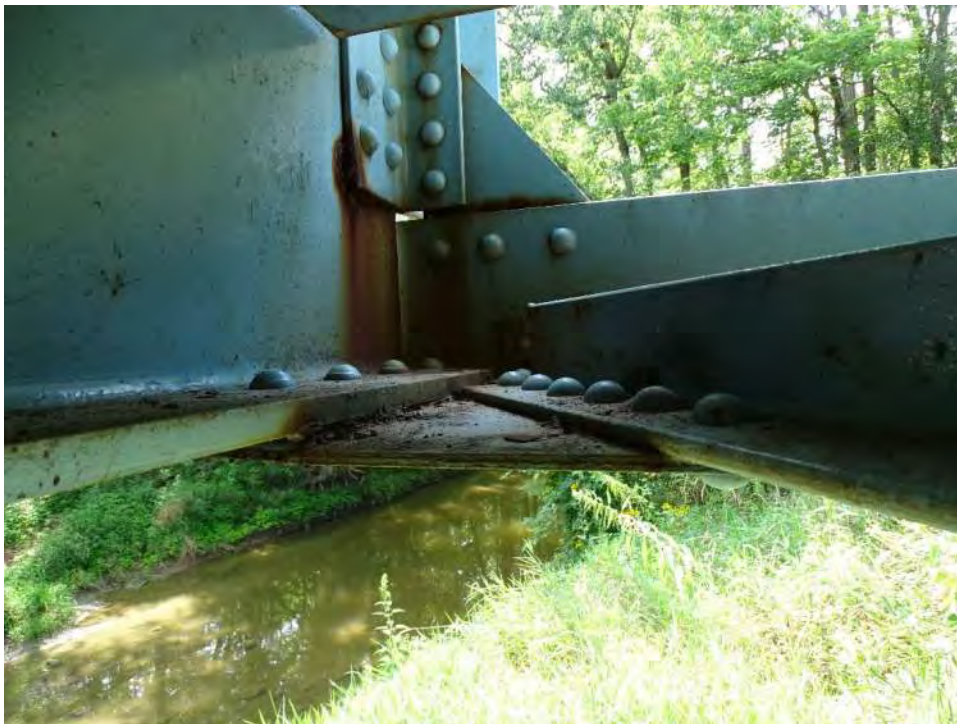
Photo 22: Looking S at L1-X - Typical Condition at Bracing Connection

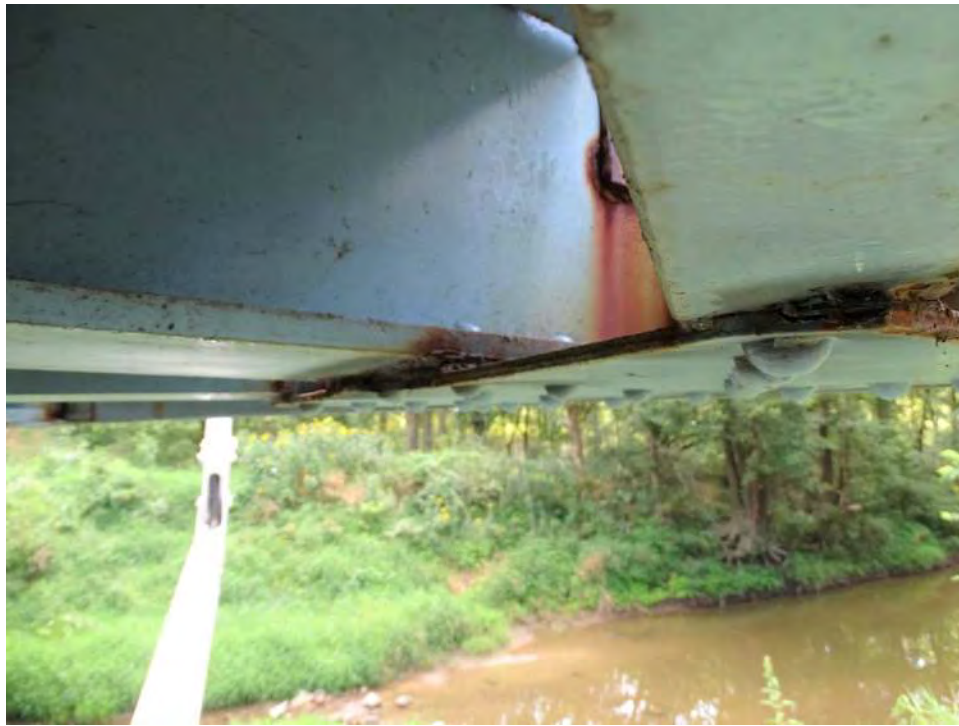
Photo 23: L1-X Lower Lateral Bracing Gusset Plate Deformation with 1/2" Pack Rust

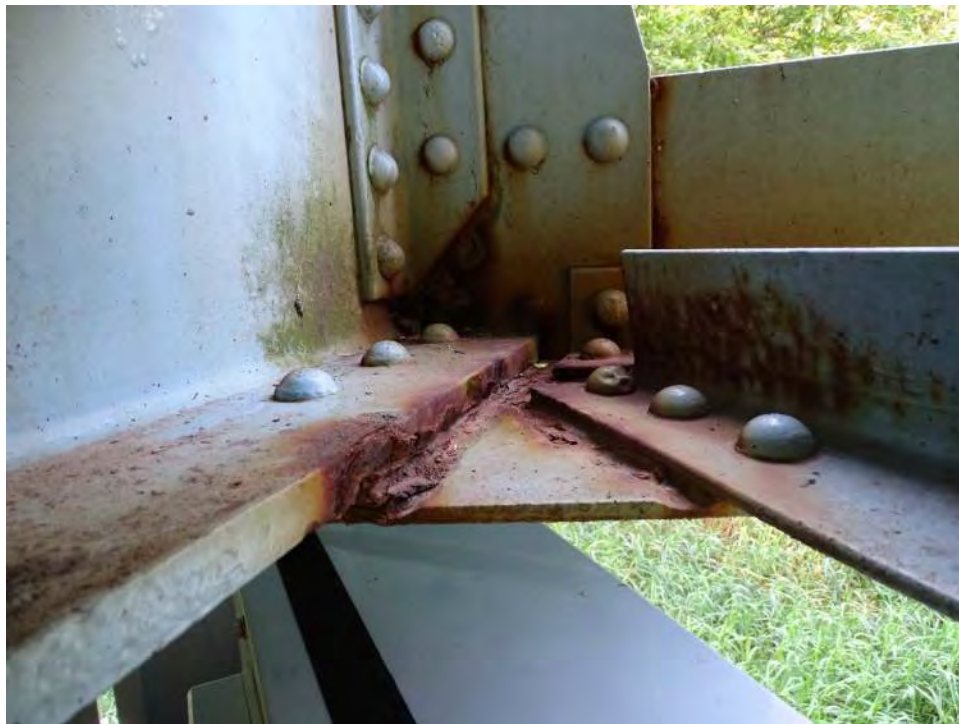
Photo 24: L2-X at FB6 - Up to 3/4" Pack Rust at Horizontal Gusset Plate at Floor Beam Connection

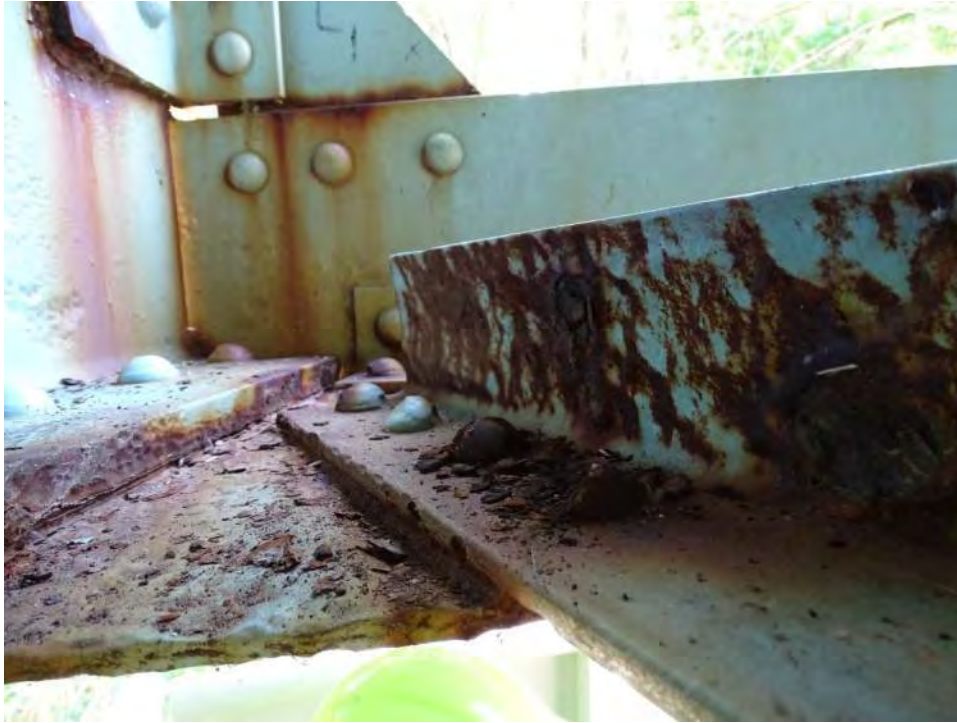
- Floor beams 2 and 3 near N. truss – bottom flanges have areas of pitting of up to 1/8" deep.
- Floor beam 4 - Corrosion "hot spots" on top of bottom flange 1/8" max. depth at 1"x1" and 2"x2" areas on west side, near the south truss.
- Floor beam 5 - Bottom flange has 1/4" section loss in bottom flange (originally 1 1/8" thick reduced to 7/8") for a 2" wide x 3" long area along the edge of the horizontal gusset plate at the north end (See Photo 19); minor section loss at edge of gusset at S. truss;
- Floor beam 7 – Section loss of ¼" x 3" x 2' long at south end (See Photo 25).

Photo 25: FB7 Horizontal Gusset Plate South End - Moderate Rust, Deep Pitting, Section Loss of $\frac{1}{4}$ " x 3" x 2'

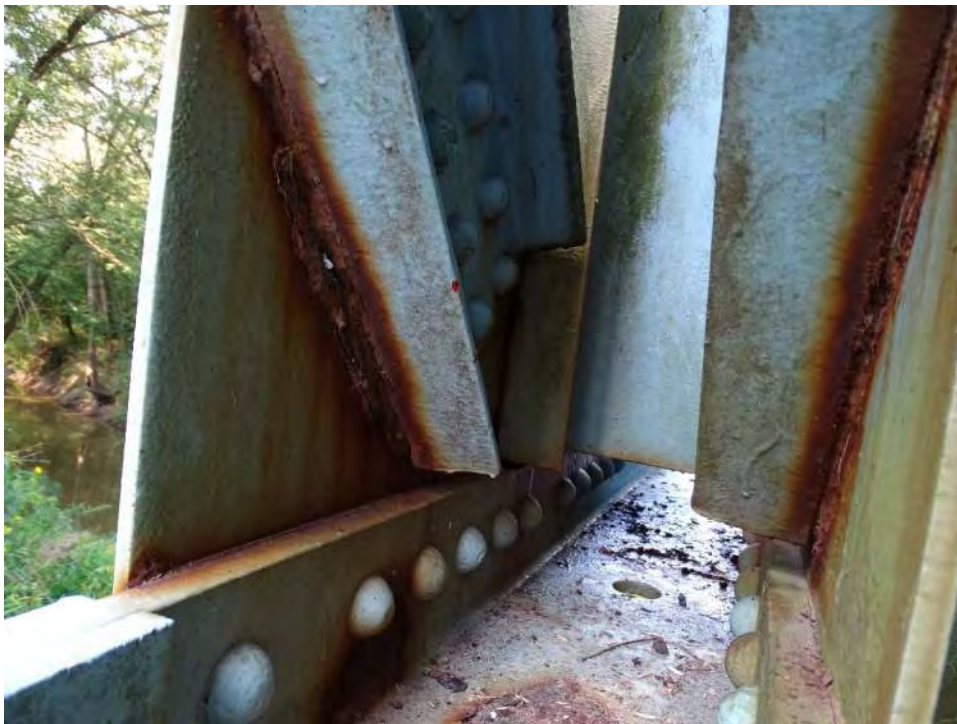
Photo 26: Truss X – West Side of L3U2 – Up to $\frac{1}{4}$ " Pack Rust at Gusset Plate

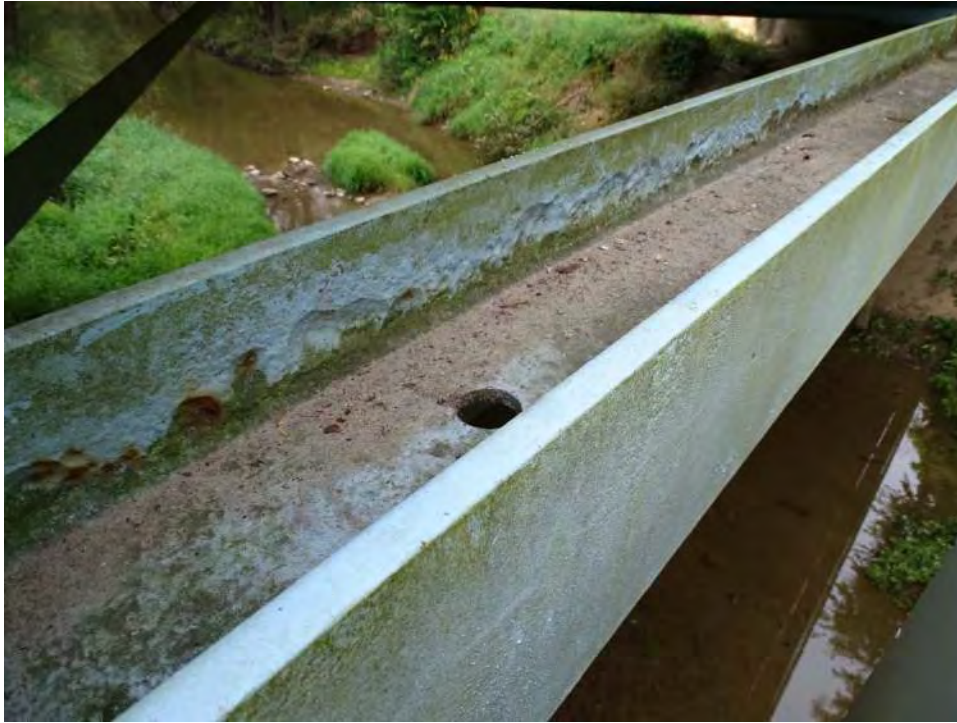
Photo 27 - L3-L4 Y, Looking East, Section Loss 1/16" to 3/4" x 3" x Full Length in Interior Vertical Leg

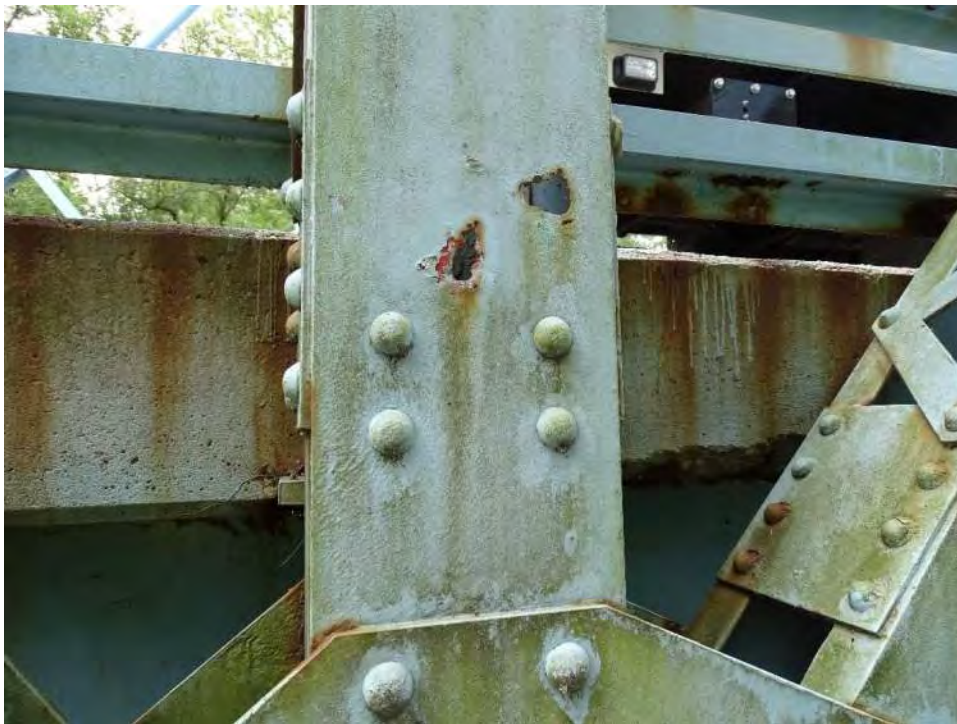
Photo 28: Truss Y L3U3 2" and 1.5" Holes in Exterior Channel

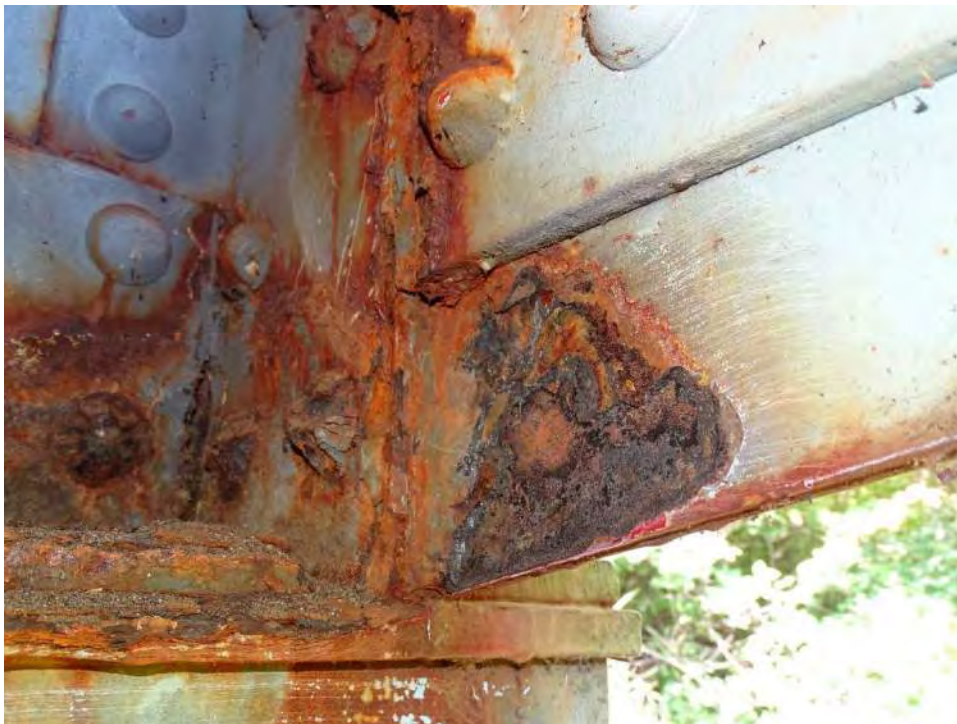
Photo 30: NW Bearing – Heavy Rust and Section Loss of Gusset Plate, Rivets, etc. Section Loss in Gusset Plate is 1/8" x 6" x 6"

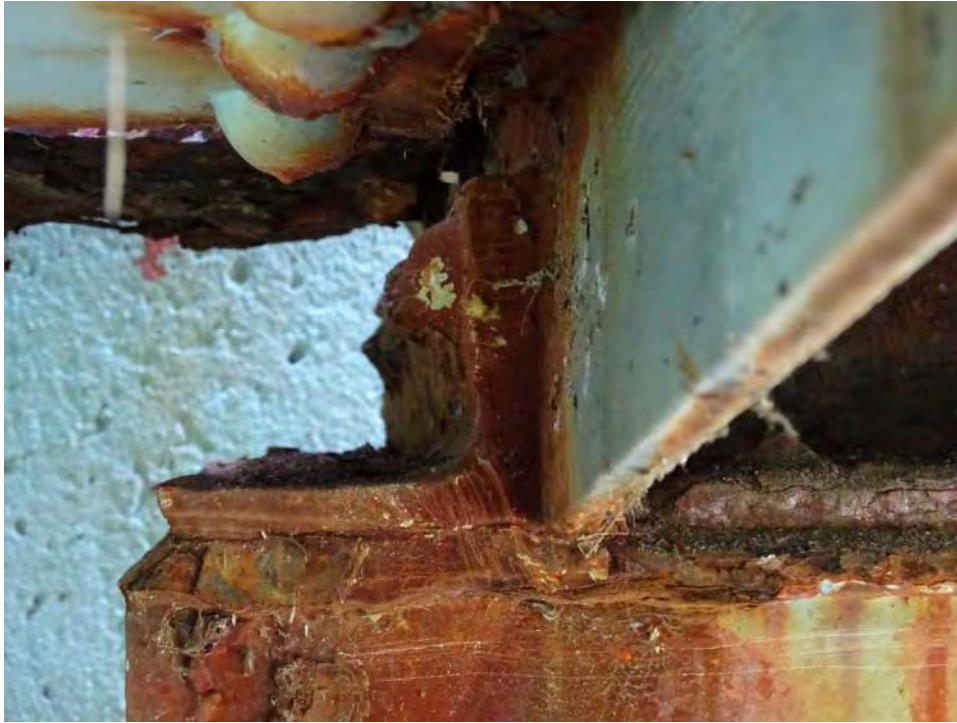
Photo 31: NW Bearing Interior Connection Angle. Note Rivet Head Section Loss.

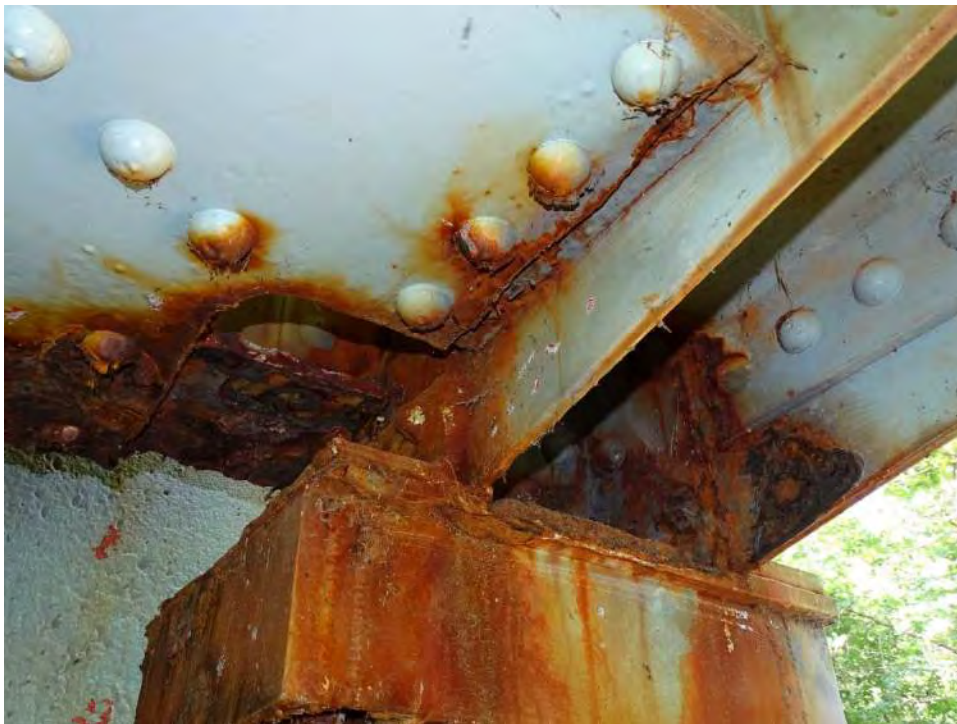
Photo 32: Gusset Plates above NW Bearing - Note Stains, Rust and Deterioration

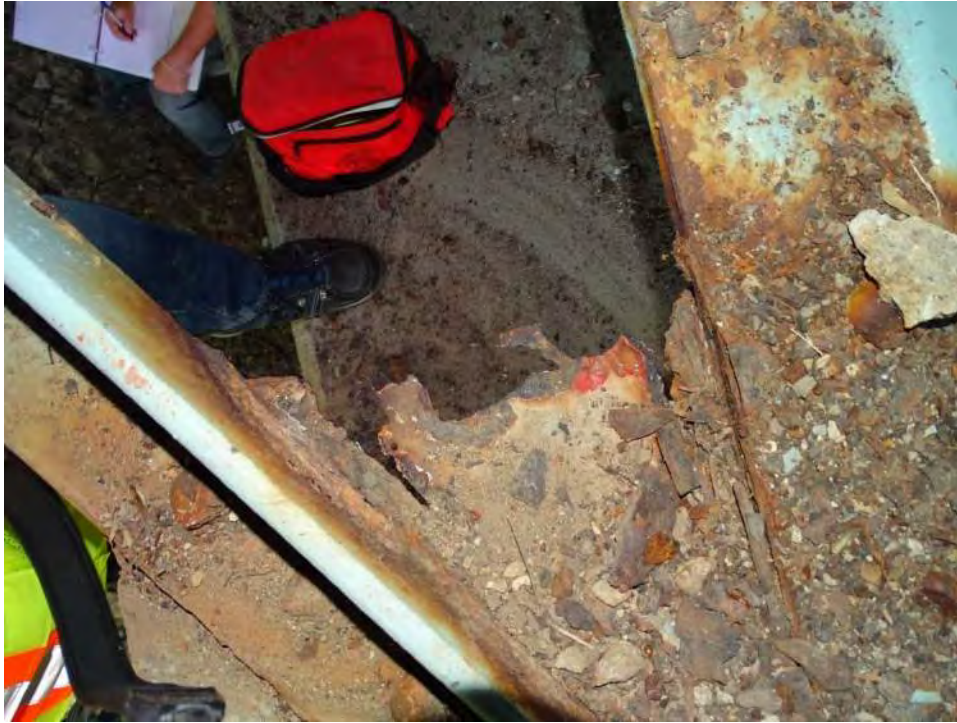
Photo 33: L0-Y Lower Lateral Gusset Plate Section Loss – Approximately 6” of Plate Gone. Viewed from Top

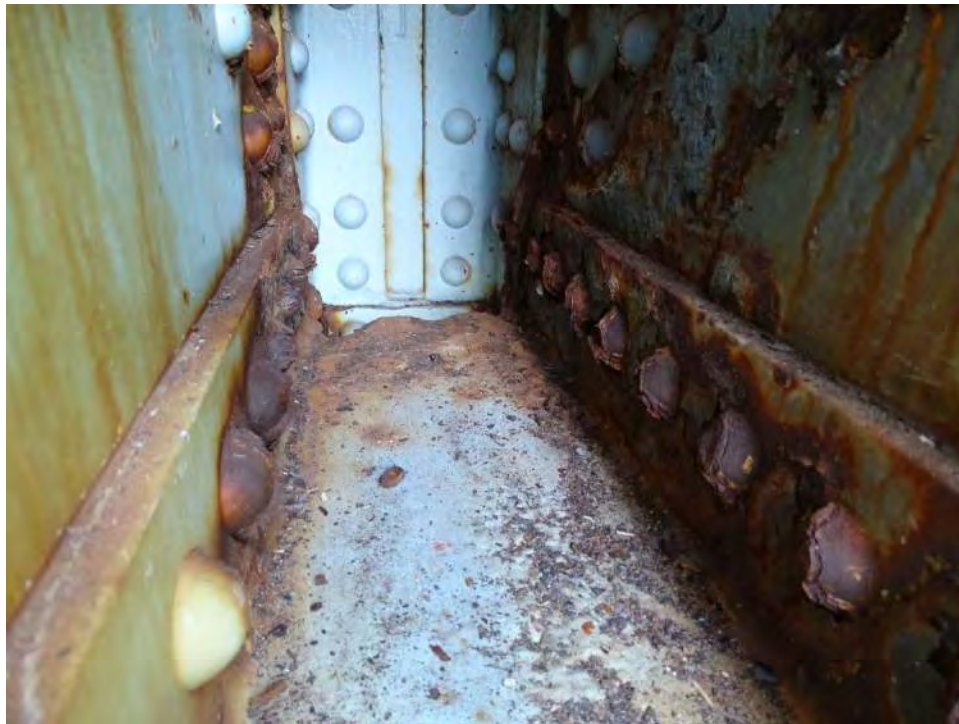
Photo 35: SE Bearing - End of Lower Chord L6L7 showing Section Loss in Web at End, Rivets and Gusset Plates. End of Lower Chord Tapers to Paper Thin. Rivets 25% to 50% Section Loss.

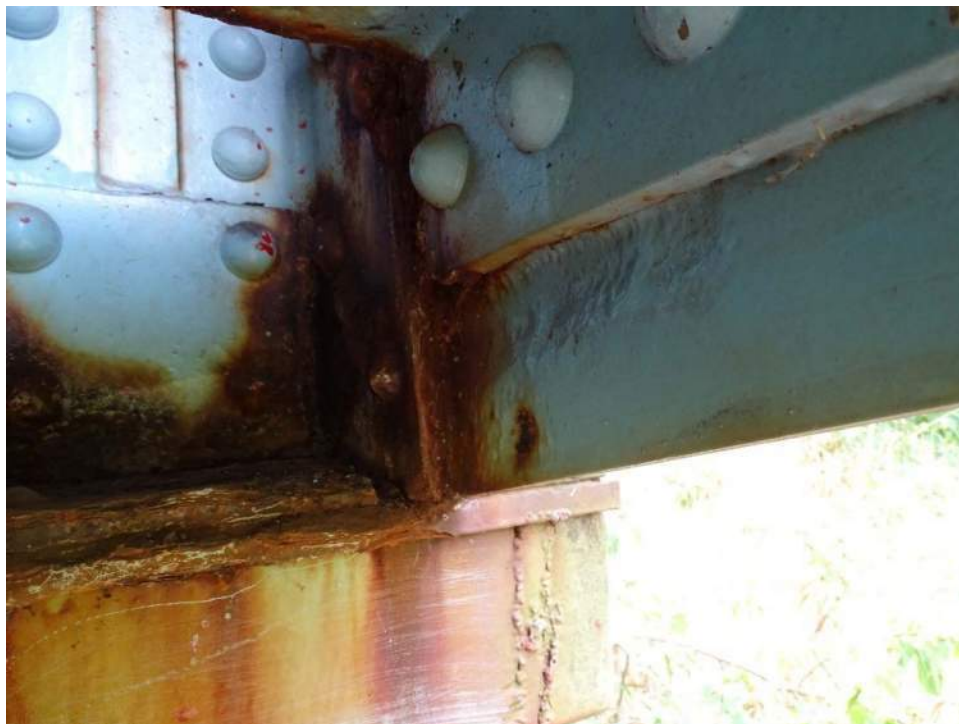
Photo 36: NE Bearing - Exterior Gusset Plate Section Loss $\frac{1}{4}$ " x 2" x 8" on Exterior Gusset Plate

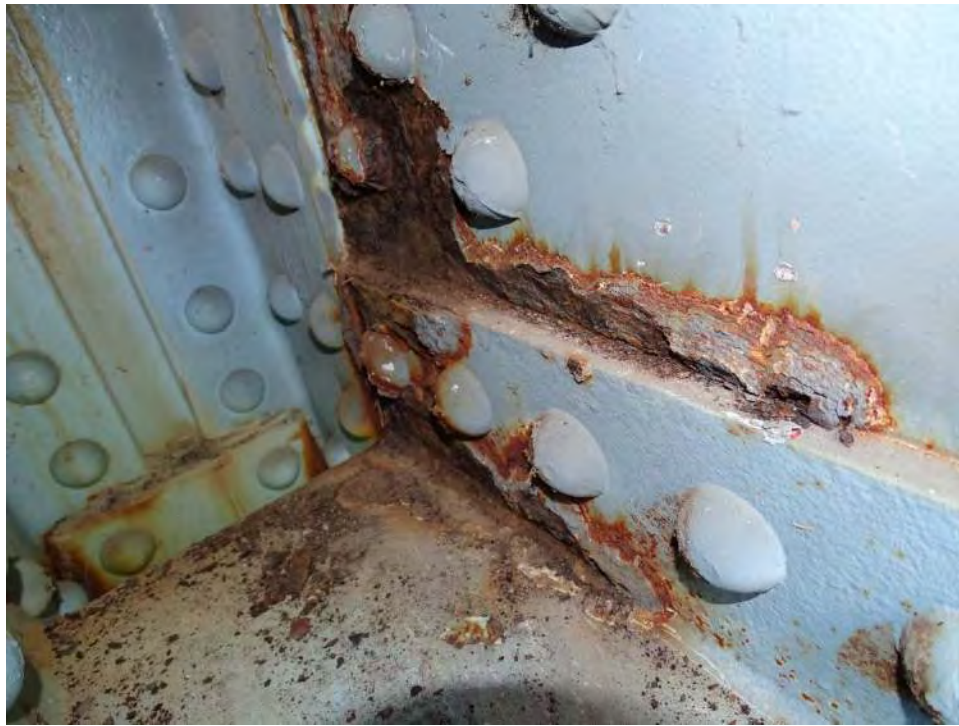
Photo 37: SW Bearing - Interior Vertical Gusset Plate Section Loss 3/8" x 2" x 12"

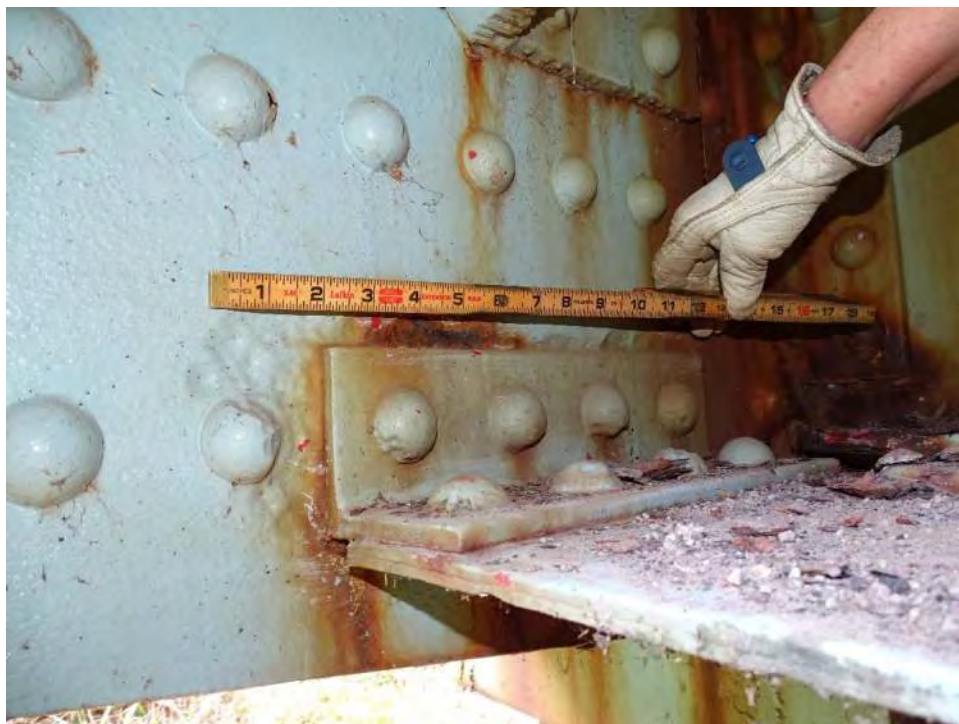
Photo 38: SW Bearing - North Face of Interior Gusset Plate Section Loss – 1/8" x 1" x 12" Along Angle.

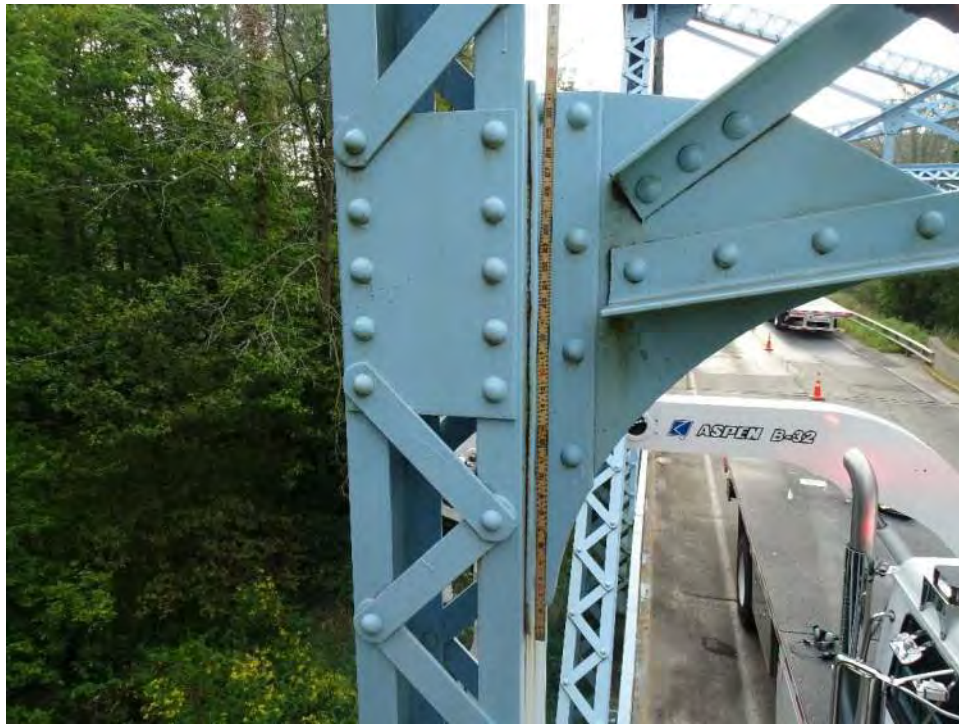
Photo 39: Truss Y - U3 (From East) Pack Rust (Typ.)

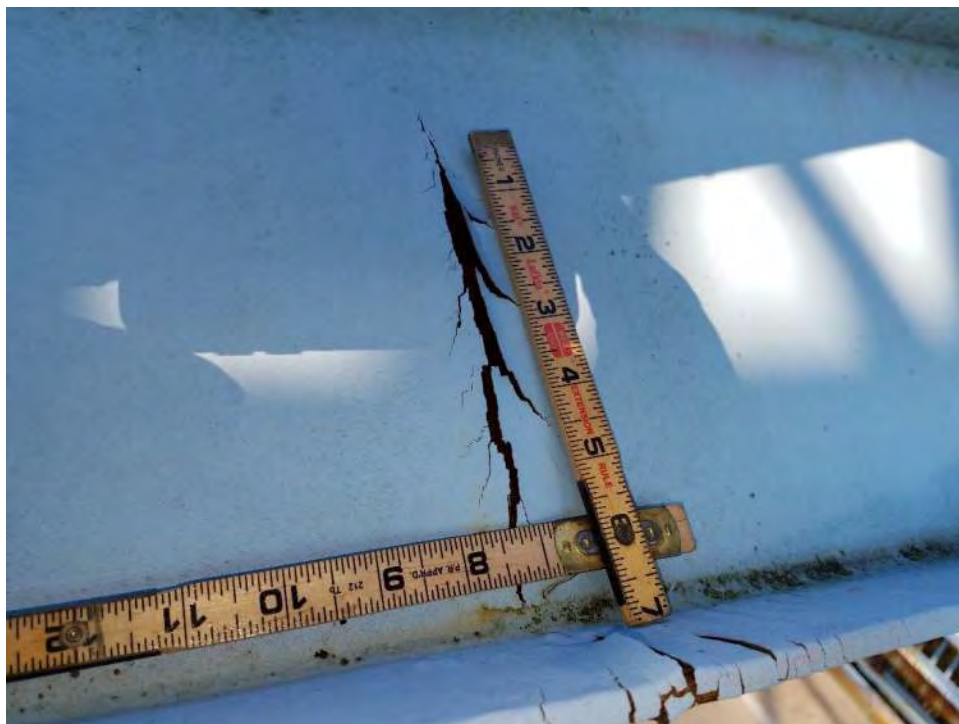
West portal has collision damage above EBL. Used binoculars to look at area from deck. No cracks noted. Channel is bent inward, with yellow paint noted on member; peeling paint on back side of bend.

Photo 40: West Portal Bracing Showing Minor Impact Damage – Split Paint

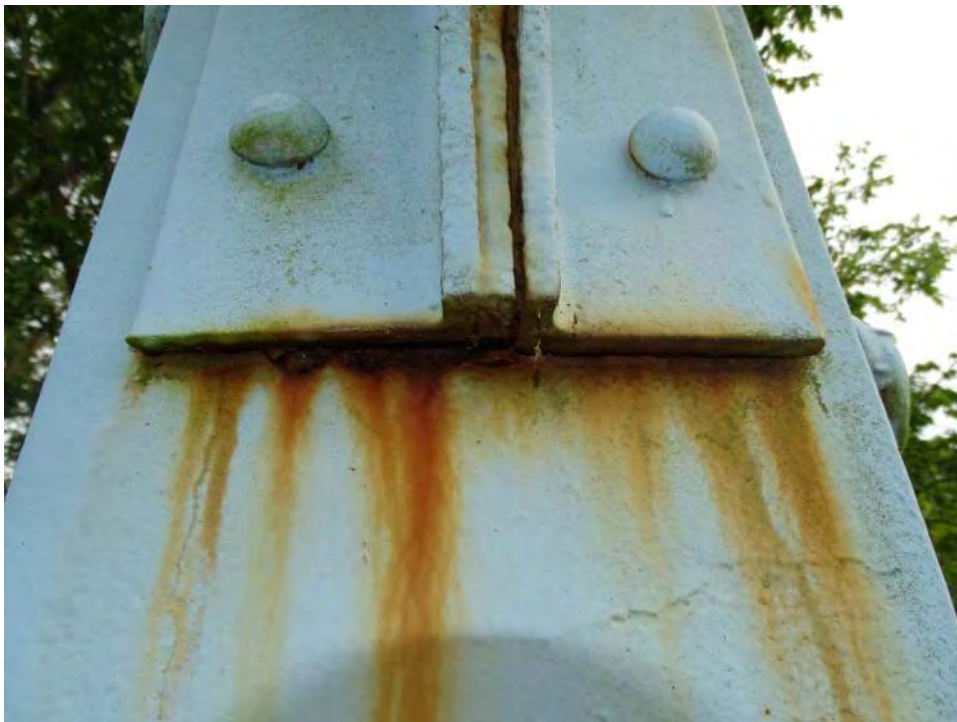
Photo 42: Portal Bracing Connection - Note Rust Stain and Minor Pack Rust
